Friday Safety Brief®

Proper Placarding of “Alternative Fuels”

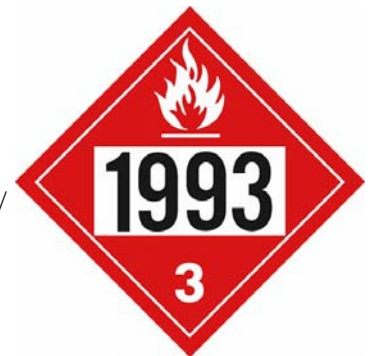
Of particular concern is a bulk transport vehicle hauling gasoline blended with more than 10% ethanol being placarded with a Flammable Liquid Flammable 3 with a UN or NA 1203 ID marking. In case of a release, that 1203 marking dictates the first responder to apply conventional Aqueous Film-Forming Foam (AFFF) to prevent or smother the petroleum fed fire. With a mixture greater than 10% ethanol, that AFFF would be ineffective. Why? The mixture is a polar/water-miscible flammable liquid and mixes readily with water which degrades the water based AFFF. Instead of AFFF, the responder must apply an Alcohol Resistant Film-Forming Fluoroprotein Foam (AR-FFF). The only way the first responder would know to use this proper retardant is if the correct placard annotating the UN 3475 ID marking was used.
